Contract #: 04-0120F4Cty: SF/ALA Rte: 80 PM: 13.2/13.9File #: 99.28**WELDING INSPECTION REPORT****Resident Engineer:** Casey, William**Address:** 333 Burma Road**City:** Oakland, CA 94607**Report No:** WIR-029933**Date Inspected:** 09-Aug-2013**Project Name:** SAS Superstructure**OSM Arrival Time:** 900**Prime Contractor:** American Bridge/Fluor Enterprises, a JV**OSM Departure Time:** 1100**Contractor:** Metalset Inc.,**Location:** Richmond, CA**CWI Name:** Dave Alvarez (QCC)**CWI Present:** Yes No**Inspected CWI report:** Yes No N/A**Rod Oven in Use:** Yes No N/A**Electrode to specification:** Yes No N/A**Weld Procedures Followed:** Yes No N/A**Qualified Welders:** Yes No N/A**Verified Joint Fit-up:** Yes No N/A**Approved Drawings:** Yes No N/A**Approved WPS:** Yes No N/A**Delayed / Cancelled:** Yes No N/A**Bridge No:** 34-0006**Component:** Hood Assemblies**Summary of Items Observed:**

Hood Assemblies:

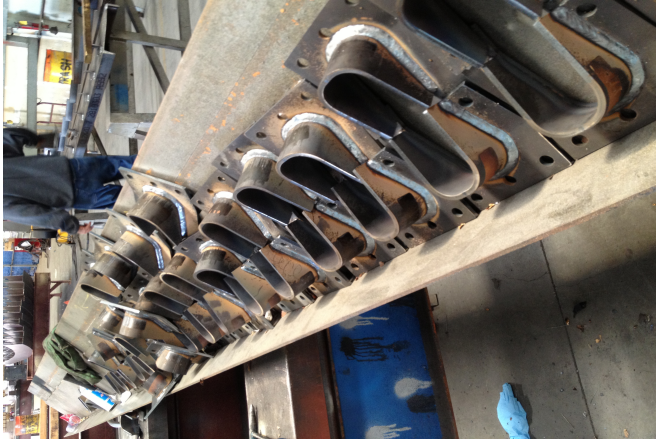
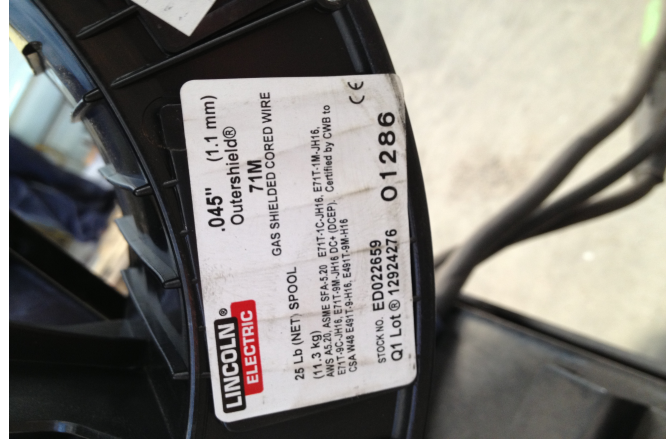
Metalset personnel fit-up and started welding fillet weld joints for piece marks P1, P3, P4 and P6. Prequalified welding procedure was available for the welder to reference. QC Inspector verified fit-up. Weld passes were cleaned by chipping and wire brush. The welding of piece remains in process.

- A square straight edge was utilized to check fit-up and alignment of assembled components.
- Welding was performed by certified welder (Cesar Ruiz).
- Weld Procedure (Fillet Weld E71T-CO) is pre-qualified for fillet weld T-Joints.
- Electrode utilized was E71T-1C-JH16, diameter .045".
